Home Inspection Report

123 Sample Dr, Any city, MD 12345

Tuesday January 1, 2019

Inside Out Home Inspector, LLC
8630M Guilford Rd #146
Columbia, MD 21046
443-559-7028

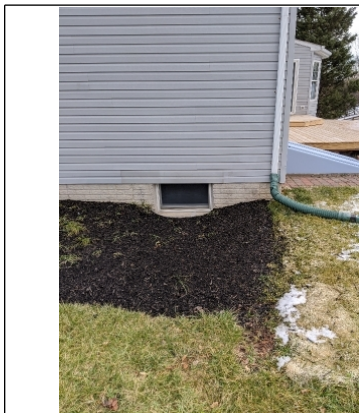
- Mulch around window wells on ride side of house is higher than window wells allowing mulch and debris to enter window well reduce drainage of water. The window well should be higher than surrounding ground to prevent water and debris from spilling in. Correct grading around window wells to direct water away from home and window wells.
- It is recommended to add covers to the window wells to prevent water from entering the window well. Without one, during heavy rainfall, it is possible for water to enter quicker than being drained resulting in the well filling and leaking into the awning windows. Add covers to direct rain away from window wells.

Negative and too high grading around window well

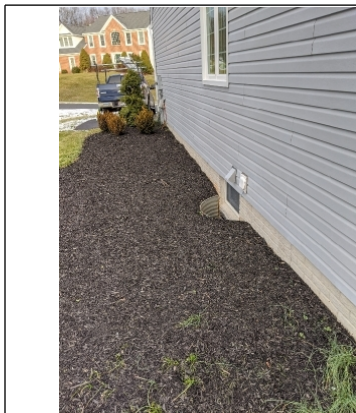
Negative and too high grading at window well

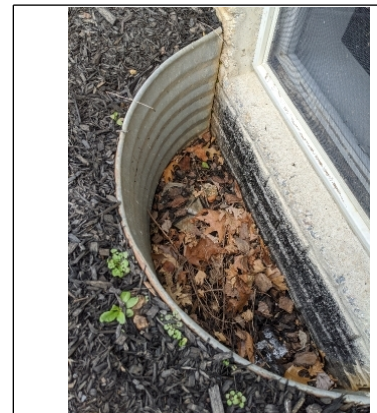
Debris entering window well

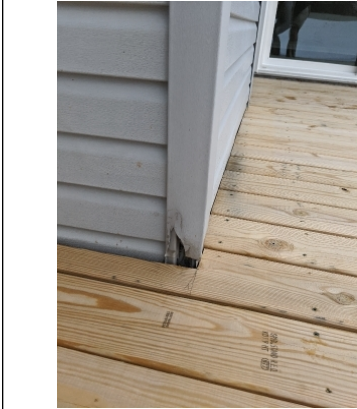
Comments Vinyl siding corner trim of chimney chase at deck and right rear corner of home damaged. Repair to prevent water and pests entering behind siding.

Damage to corner trim at deck

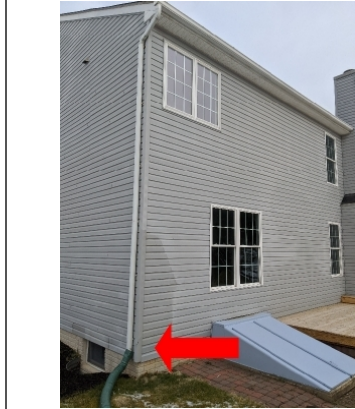
Right rear corner of home

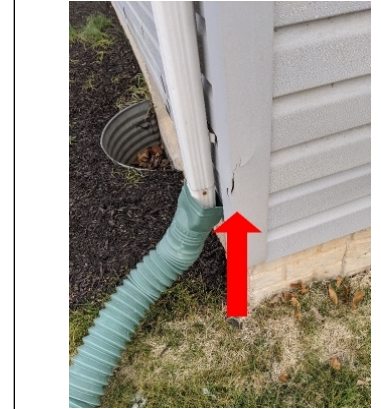
Damaged corner trim close-up

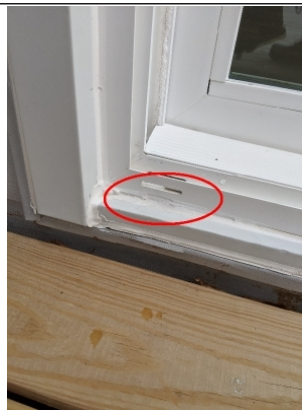
- Sliding door at deck has caulk restricting bottom weep holes. Clear these holes to ensure sliding door can drain water properly to avoid damage to home.
- Lock mechanism for sliding door in eat-kitchen are onto deck did not function. Replace lock for improved safety.
- Bilco steel door cover for basement steps has a concave top allowing water to puddle against the home and is causing rust to the cover. The cover is designed to shed water and correction is needed to prevent damage to the home and prolong the life of the cover. Once puddling corrected, take appropriate action to remove rust and repaint cover.
- Bilco steel door cover needs sealant added between wall and cover to prevent water intrusion.

Weep hole has been caulked over

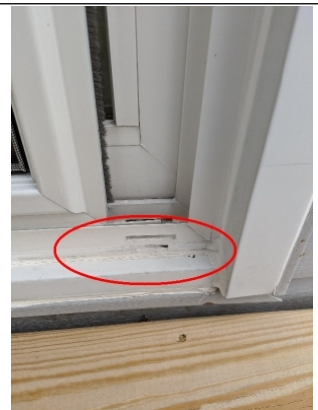
Weep hole caulked

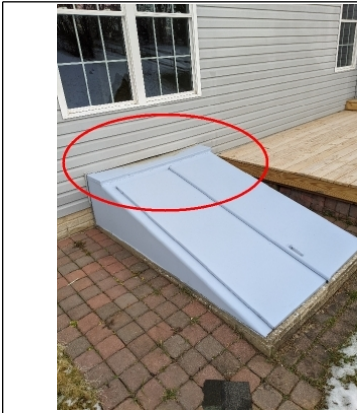
Water accumulation on top of Bilco step cover

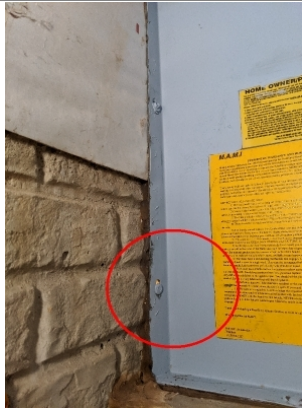
No apparent sealant. Seal to prevent water entering

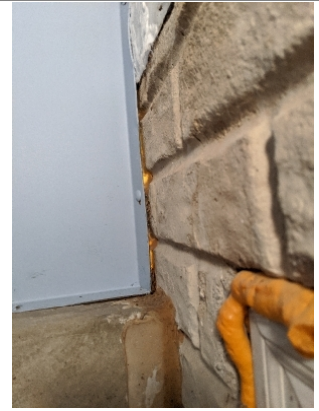
Reseal to prevent water

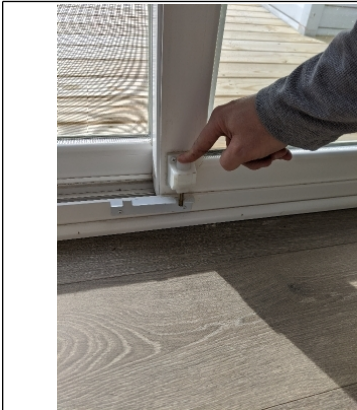
Lock mechanism would not engage on sliding door

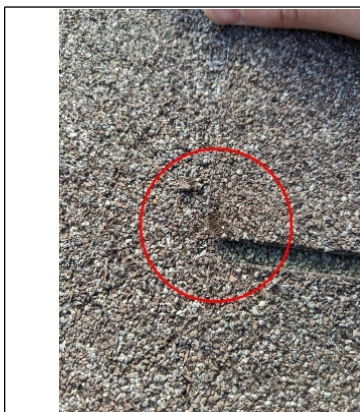
Comments Roof appeared to be nearing end of its useful life, budget to replace soon.

Shingles are brittle due to temp and age

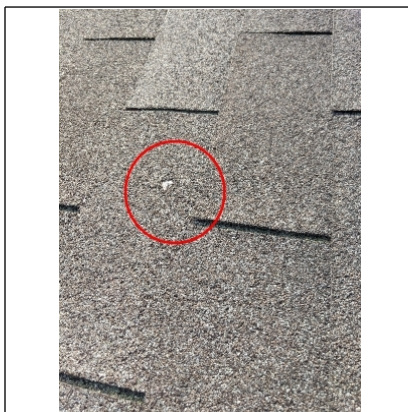
Blistering, typical for shingles at end of useful life

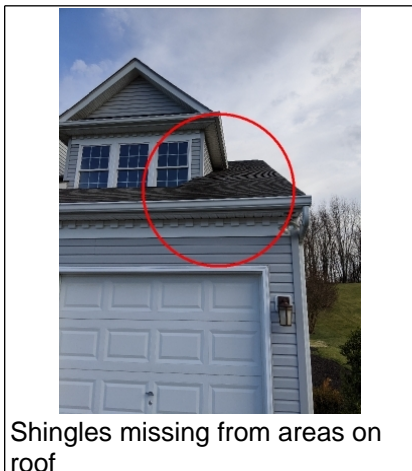
- Roof appeared to be nearing end of its useful life, budget to replace soon.
- Roof shingles observed in yard and missing on roof. Replace missing shingles to avoid water penetrating roof and causing damage to home.

Shingles missing from areas on roof

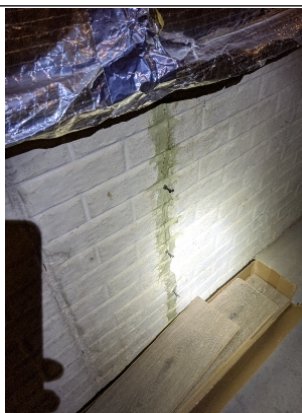
Comments Injection repairs visible on foundation walls in unfinished area for vertical cracks. No moisture or movement observed. Consult with sellers for any information relating to the repairs and warranties that may transfer.

Injection repair of foundation example

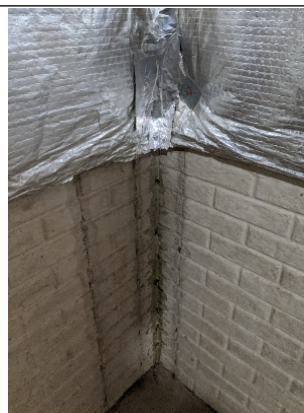
Example of repair to foundation

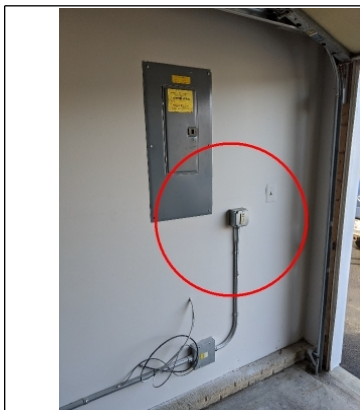
- Outlet next to service panel did not operate during inspection. Have corrected by licensed electrician to restore function.
- Cover plate for outlet on ceiling missing. Add cover plate for improved safety.
- Light fixtures in garage did not operate. Replace bulb and if unresolved, have corrected by a licensed electrician to restore lighting in garage.

Outlet did not operate

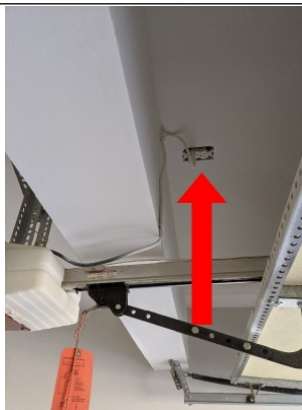
Cover plate missing

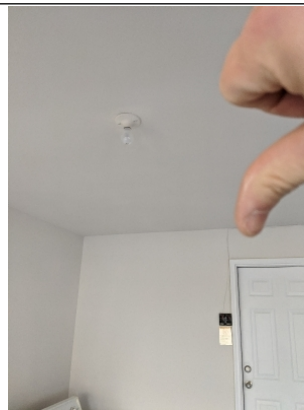
Light fixture on ceiling did not operate

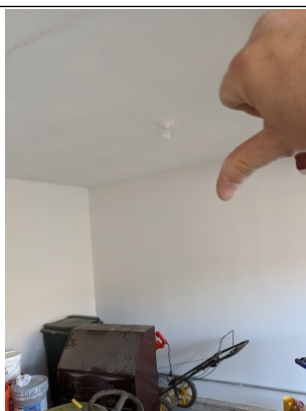
Light fixture did not operate

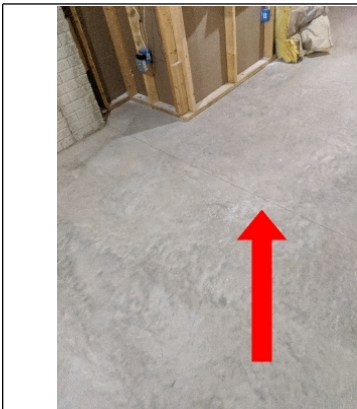
- Double doors in basement leading to back room did not latch. Adjust and fix to improve privacy.
- Crack in concrete floor in rear of unfinished basement area. No movement observed. Seal to prevent radon gas and moisture entering basement.
- Insulation missing from box joists under eat-in kitchen in unfinished area of basement. Add insulation to prevent energy loss and improve comfort.
- Exposed paper backed insulation in the unfinished area of basement is a fire hazard per the warning. Remove or cover insulation for improved safety.

Crack in basement floor

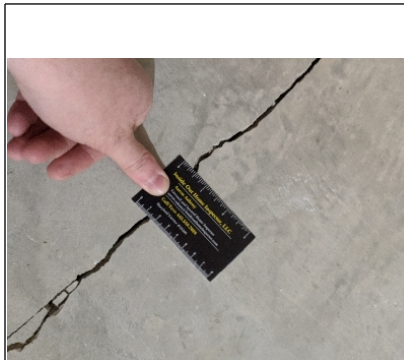
Basement floor crack

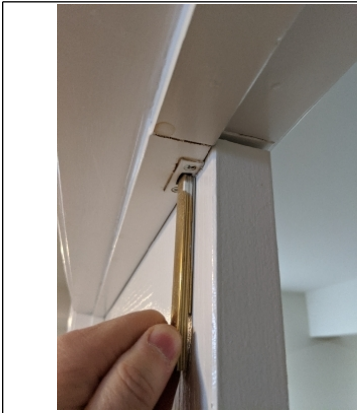
Could not latch one door of the double doors

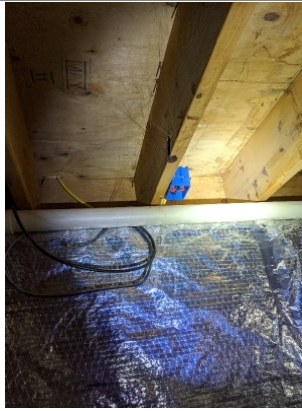
Junction box missing cover plate

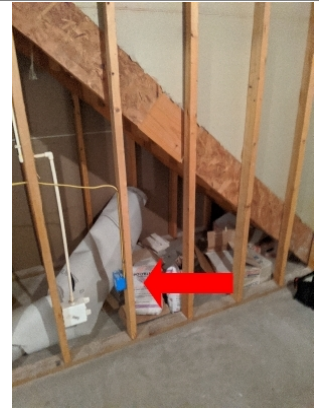
Outlet missing cover plate

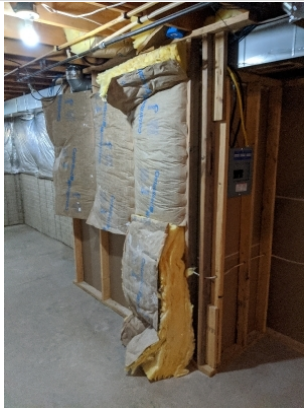
Exposed insulation in unfinished basement area

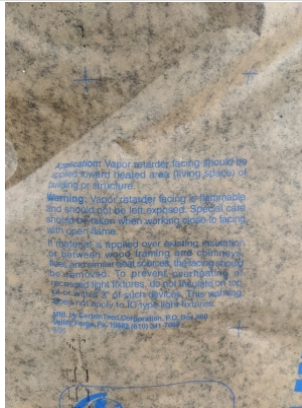
Warning on insulation to not be left exposed

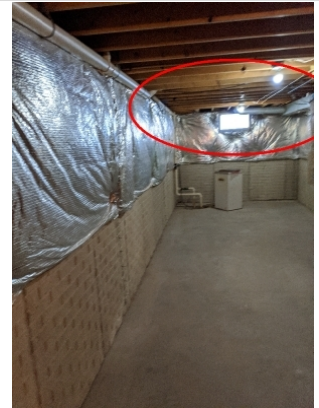
No insulation in cantilever joists under eat-in kitchen

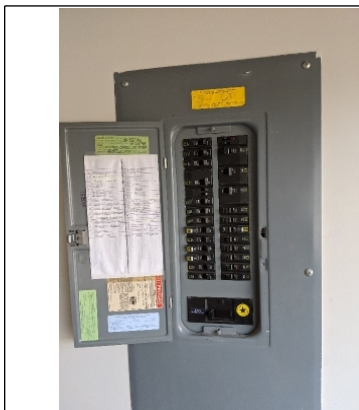
- Labeling does not show the subpanel in basement and oven/range did not appear correct.
- Neutrals and grounds should not share a lug on bus bar and should be separate for safety.
- Recommend having the panel further evaluated and the necessary corrections made by a licensed electrician.

Labeling appeared to not be correct

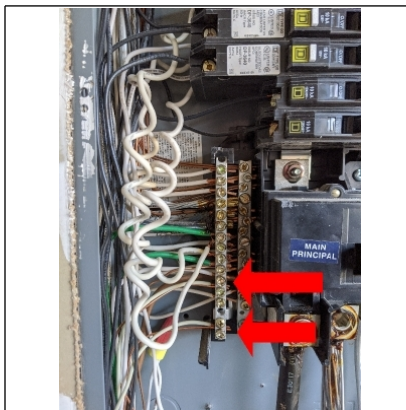
Neutral and ground sharing lug on bus bar

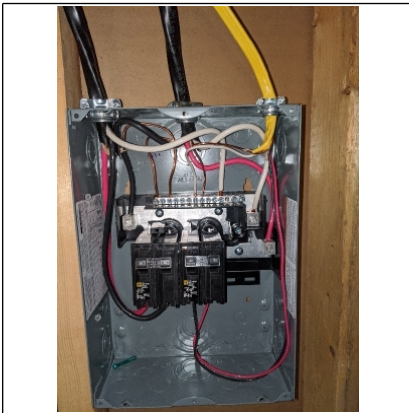
Sub panel

Branch wire ☒ Copper ☐ Aluminum ☐ Solid Branch Aluminum Wiring ☐ Not Visible
☐ Neutral/Ground Wiring Separated Observations: ☐ Double Tapped Breaker ☐ Evidence Of Arcing
☐ Melted Wiring Sheathing ☐ Undersized Wire/Oversized Breaker ☒ Unlabeled Breaker In Use
☐ Breaker Shut Off ☐ Knob/Tube Wiring ☐ Cloth Wrapped Wiring ☐ Knockout Bushing Missing
☐ Empty Knockout ☐ Safety Hazard

Recommend having subpanel corrected by licensed electrician for safety and function.

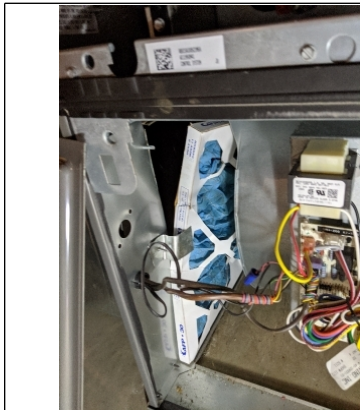
- The furnace is 100,000 BTU and requires adequate combustion air for proper burning and ventilation. The furnace and water heater (75,000 BTU) share the unfinished area in basement, which could constitute a confined space for combustion air. Recommend further evaluation by a qualified licensed HVAC/Plumbing professional to ensure adequate combustion air present to avoid a backdraft and safety hazard .

Air filter replacement obstructed and in blower service section of furnace

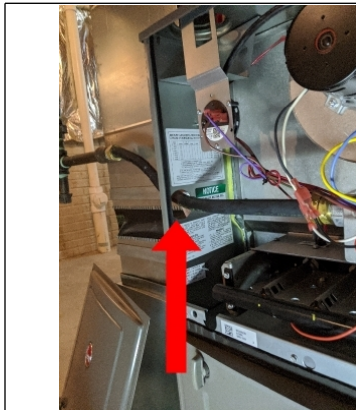
Flex pipe through knockout should be rigid pipe

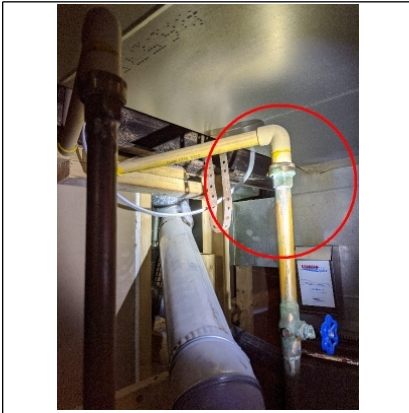
Corrosion/leak of cold water supply

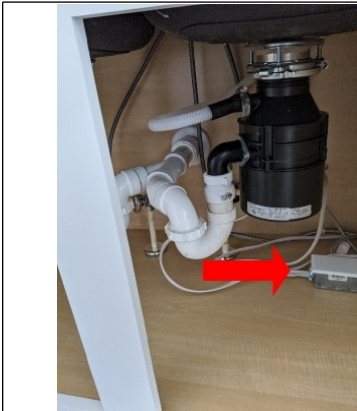
Junction box under kitchen sink located on base of cabinet making it subject to damage by water if leak occurs. Relocate junction box to wall of cabinet for improved safety.

Junction box base of kitchen sink cabinet

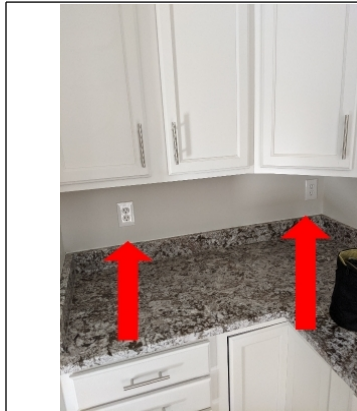
Kitchen counter outlets not GFCI

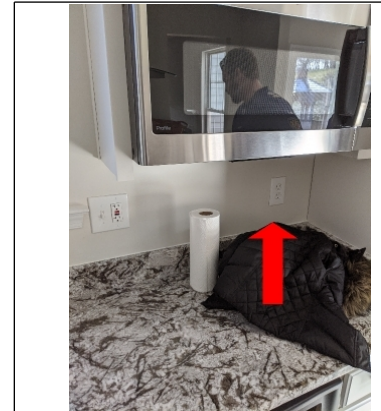
Outlet not GFCI

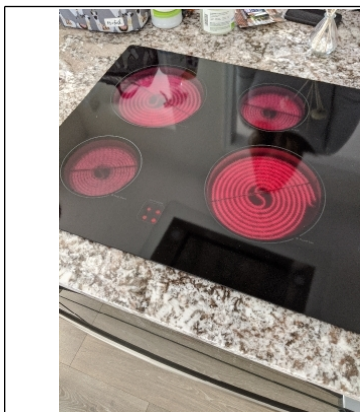
Operated a few seconds and tripped breaker

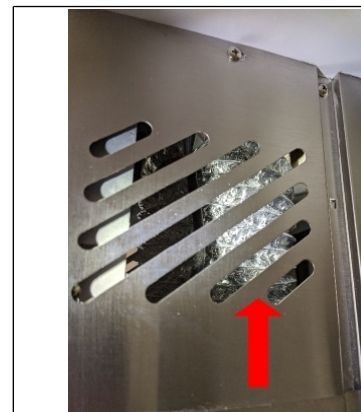
The hood vent for the range has foil flex duct installed which has ridges and can trap grease. Replace with rigid duct with smooth interior surface to avoid a potential hazard and improve performance of the hood vent.

Foil flex duct installed in hood vent

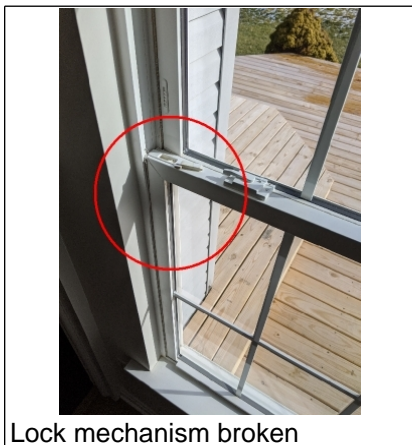
Comments Window on right side of fireplace tilt lock broken. Replace hardware to secure window sash.

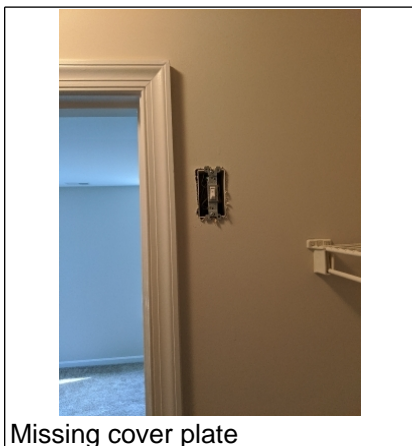
Comments Switch for attic light in the closet is missing cover plate. Add plate to avoid electrical shock risk and improve safety.

Missing cover plate

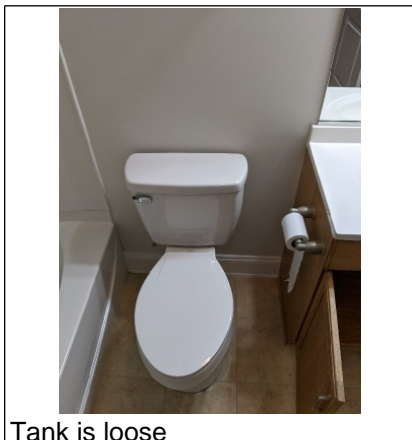
Tank is loose

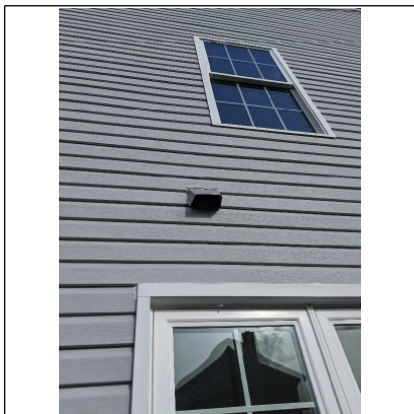
Comments Exhaust fan vent flap pinned shut by siding. Correct to ensure proper venting of bathroom.

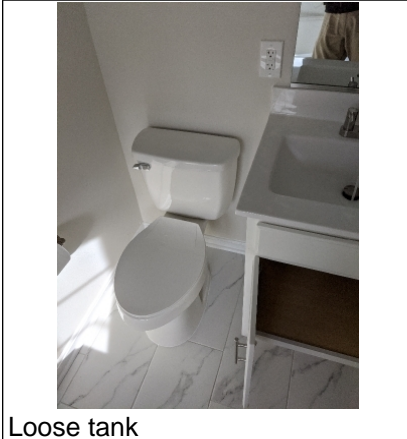
Loose tank

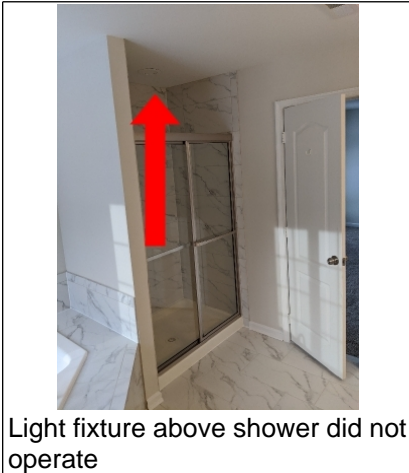
Comments Light fixture above shower did not operate. Repair or replace with fixture appropriate for wet location.

Light fixture above shower did not operate

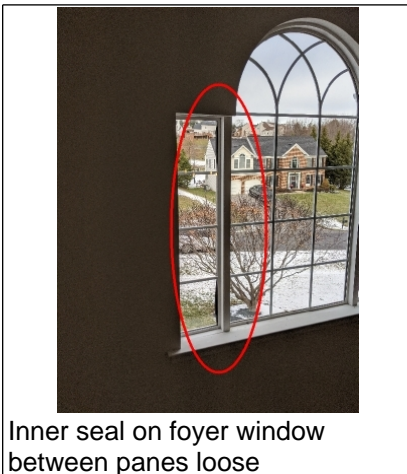
Comments Inner seal between panes of foyer window has come loose inside. No fogging or condensation observed at time of inspection but usually indicates a failure in the thermal seal and efficiency of the window. Replace window to restore energy efficiency if window begins to show signs of moisture between the panes.

Inner seal on foyer window
between panes loose

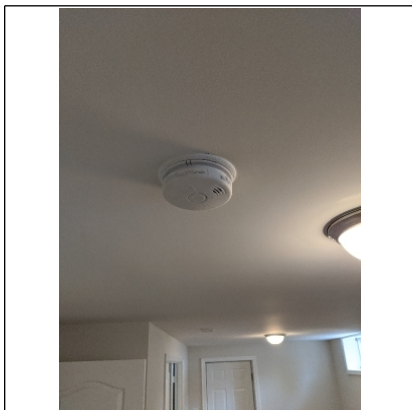
Smoke and carbon monoxide detector in basement rear room had paint sprayed on it
