Home Inspection Report

123 Sample Dr, Any city, MD 12345

Tuesday January 1, 2019

Inside Out Home Inspector, LLC
8630M Guilford Rd #146
Columbia, MD 21046
443-559-7028

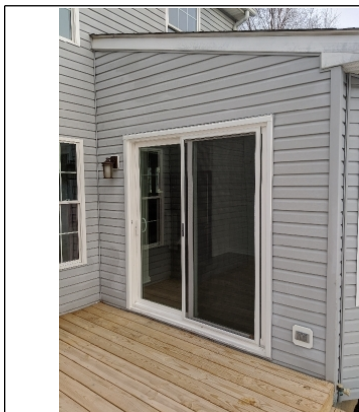
- Sliding door at deck has caulk restricting bottom weep holes. Clear these holes to ensure sliding door can drain water properly to avoid damage to home.
- Lock mechanism for sliding door in eat-kitchen are onto deck did not function. Replace lock for improved safety.
- Bilco steel door cover for basement steps has a concave top allowing water to puddle against the home and is causing rust to the cover. The cover is designed to shed water and correction is needed to prevent damage to the home and prolong the life of the cover. Once puddling corrected, take appropriate action to remove rust and repaint cover.
- Bilco steel door cover needs sealant added between wall and cover to prevent water intrusion.

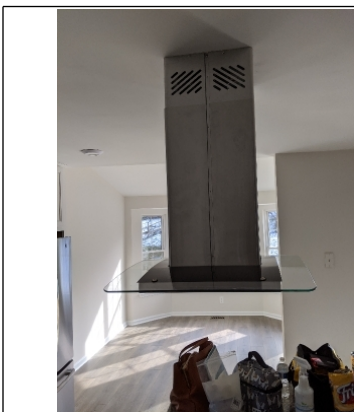
Hood vent over island range

1. Window wells missing covers and grading at exterior right side of home
2. Vinyl siding corners damaged at chimney chase and rear corner of home
3. Bilco door cover collecting water and needs resealed
4. Loose handrail basement stairs
5. Insulation missing in rim joist area at rear of unfinished basement
6. Living room window tilt hardware broken
7. Sliding door lock eat-in kitchen
8. Exhaust fan vent flap for bathroom 2 pinned shut by siding
9. Crack in basement floor
10. Kitchen range hood duct
